Manhole Inspection Summary

Manhole # **S43GG_007MH**

Insp Date: **1/4/08 10:57 AM**

Location Address: **1400 BOND ST**

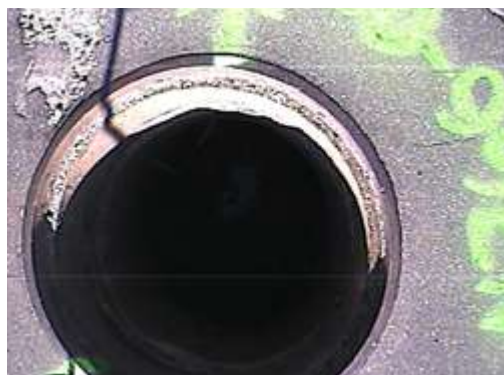
Defect 1

Steps Count: **5** Missing: **4** ☒ **Corroded**

STEPS CORRODED

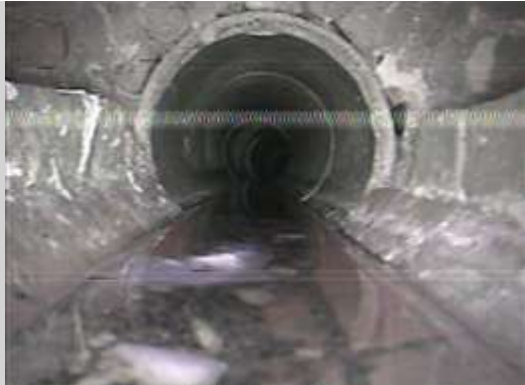
12 O'Clock Outflow

8 in. Circular Gravity Sewer
Pipe Out @ 12 O'Clock

Pipe Height: (in.) Direct
Pipe Material: **Clay** ☐ Pipe Lined
Invert Depth: **8.99** (ft.) Flow Characteristics: **Slow**
Deposits: ☒ None ☐ Mud ☐ Sludge ☐ Debris ☐ Grease
Silt Depth: (in.) Deposits Extent:
Infiltration: **None** Pipe Seal Cond: **Cracked**

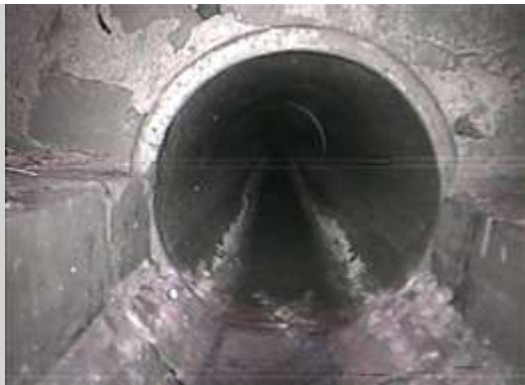
7 O'Clock Inflow

8 in. Circular Gravity Sewer
Pipe In @ 7 O'Clock

Pipe Height: (in.) Direct
Pipe Material: **Clay** ☐ Pipe Lined
Invert Depth: **8.98** (ft.) Flow Characteristics: **Slow**
Deposits: ☒ None ☐ Mud ☐ Sludge ☐ Debris ☐ Grease
Silt Depth: (in.) Deposits Extent:
Infiltration: **None** Pipe Seal Cond: **Sound**
